**Market Appraisal
Of
An Economic Viability assessment for continued use as a Nursery
For the site identified as
Fibrex Nurseries
Honeybourne Road
Pebworth
Worcestershire
CV37 8XP
Ordnance Survey Grid Reference SP127465
For
Sam Back BSc (Hons)
Senior Land Buyer, Cala Homes Midlands Limited
Cala House
Arleston Way
Solihull
Midlands
B90 4LH**

**RE: An Economic Viability Appraisal for the glasshouse nursery located at Fibrex Nurseries,
Honeybourne Road, Pebworth, Worcestershire, CV37 8XP
Ordnance survey grid reference SP127465
Tenant: Fibrex Nurseries Limited**

A photographic schedule of condition

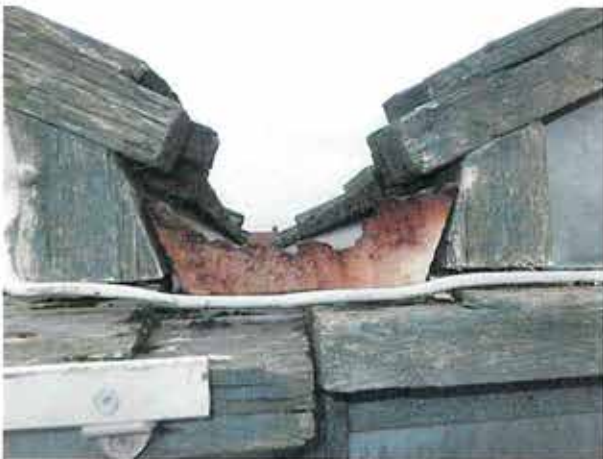
Fibrex Nurseries 04 12 18 (35)

- 32 View of the second bay, note the permanent benching
 - 33 View of the next Westlock widespan greenhouse
 - 34 Internal view of the glasshouse
 - 35 View of the gutter end, this shows the amount of erosion and decay which has taken place to both the galvanised steel gutter and the timber glass supports forming the Dutch frames

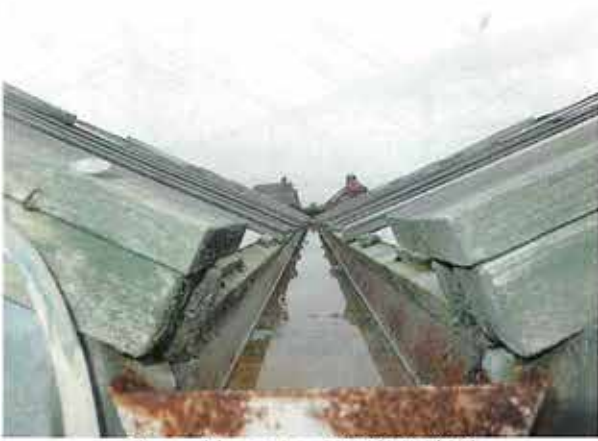
Fibrex Nurseries 04 12 18 (41)

- 40 Internal view of the Westlock greenhouse
 - 41 View of the gutter, the galvanised steel is showing serious signs of metal erosion primarily caused by water sitting in the gutter over many years
