Stage 1 Road Safety Audit

Orchard Farm, Pershore

Formula Land

18 March 2024

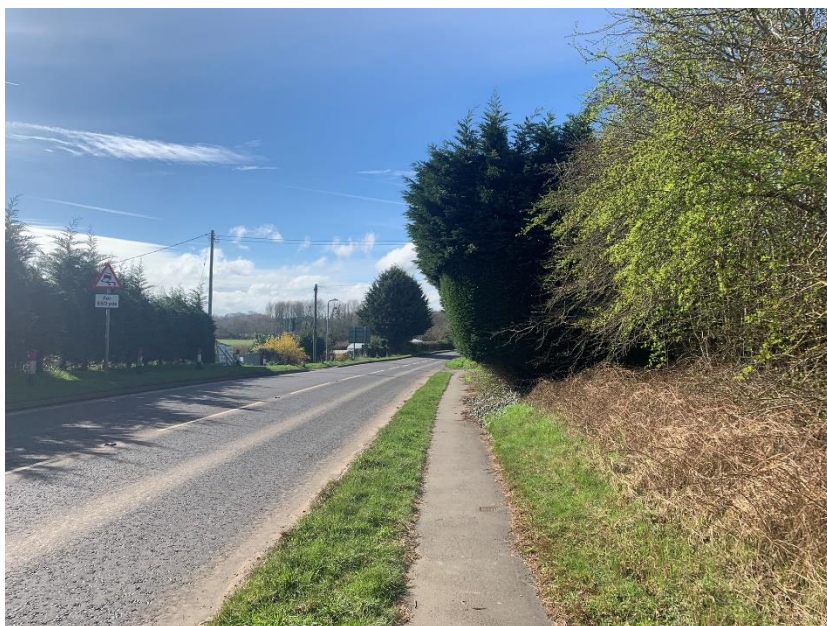
Photograph 1 – Trees encroaching the footway

Location C Proposed footway along the Cemetery frontage.

Summary: Trees are overhanging onto the footway reducing the effective width for pedestrians.

The existing trees are overhanging, reducing the effective width and causing an obstruction on the footway, as shown in **Photograph 1**. This could cause pedestrians to step into the carriageway to avoid obstacles / other pedestrians, which could lead to pedestrians being struck by passing vehicles.

It is recommended that the existing trees are regularly maintained / pruned to ensure the safety of the pedestrians walking along this footway.

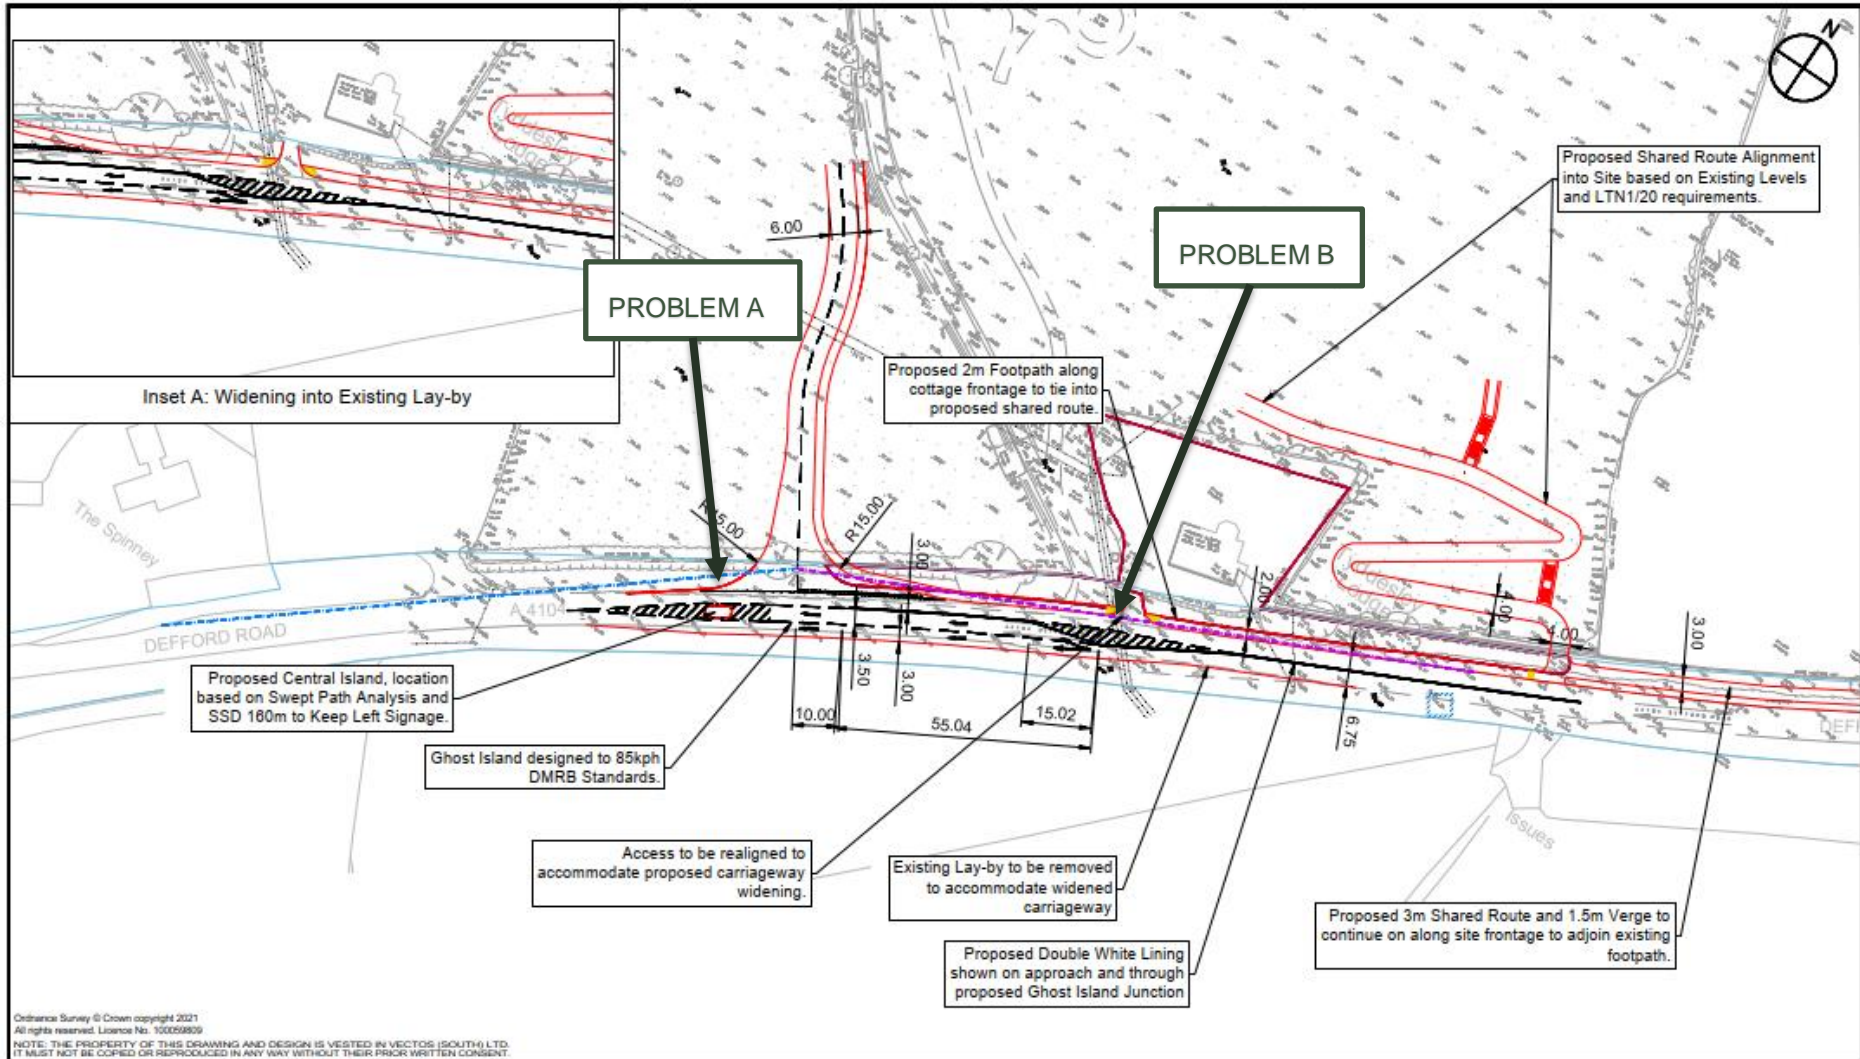
227119_PD02 Rev N – Proposed 50mph Ghost Island Arrangement

Location A: Proposed site access junction.

Summary: Existing vegetation may obscure visibility splay to the left of the site access potentially leading to sideswipe type collisions.

Onsite observations noted that the presence of existing vegetation may constitute an obstruction to the junction visibility. Obstruction to the junction visibility splays may lead to injudicious vehicle movements at the proposed junction, potentially leading to side swipe type collisions between vehicles.

Location B: Ghost island at site access.

Summary: The lead in taper appears too short for the recorded 85th percentile speeds leading to shunt type collisions.

The lead in taper length at the ghost island appears too short and would not give drivers enough time to safely merge onto the right-hand turn lane and could lead to loss of control or rear end shunt type collisions.

It is recommended that the vegetation to the left of the site access junction be cut back and maintained such that it does not pose an obstruction to the visibility splays.

It is recommended that a longer taper length is provided as this would allow drivers more time to adjust their speed and merge smoothly, reducing the risk of collisions.
