**Market Appraisal
Of
An Economic Viability assessment for continued use as a Nursery
For the site identified as
Fibrex Nurseries
Honeybourne Road
Pebworth
Worcestershire
CV37 8XP
Ordnance Survey Grid Reference SP127465
For
Sam Back BSc (Hons)
Senior Land Buyer, Cala Homes Midlands Limited
Cala House
Arleston Way
Solihull
Midlands
B90 4LH**

**RE: An Economic Viability Appraisal for the glasshouse nursery located at Fibrex Nurseries,
Honeybourne Road, Pebworth, Worcestershire, CV37 8XP
Ordnance survey grid reference SP127465
Tenant: Fibrex Nurseries Limited**

A photographic schedule of condition

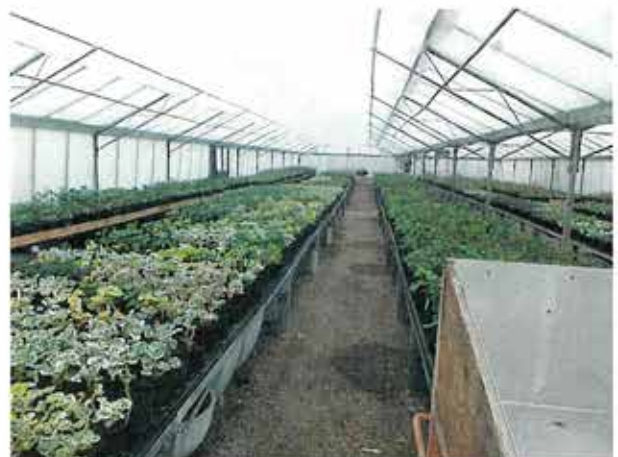
Fibrex Nurseries 04 12 18 (32)

- 32 View of the second bay, note the permanent benching
 - 33 View of the next Westlock widespan greenhouse
 - 34 Internal view of the glasshouse
 - 35 View of the gutter end, this shows the amount of erosion and decay which has taken place to both the galvanised steel gutter and the timber glass supports forming the Dutch frames

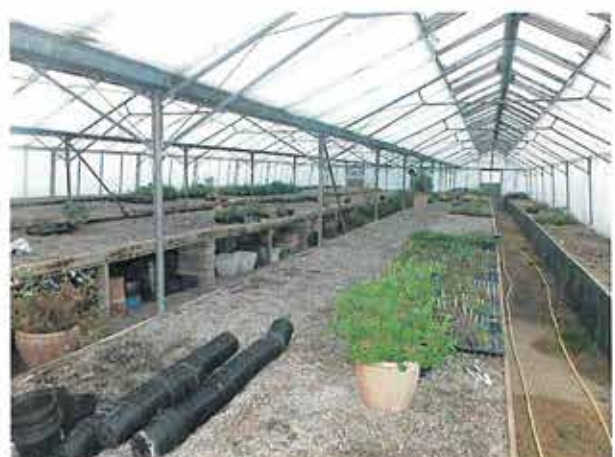
Fibrex Nurseries 04 12 18 (40)

- 40 Internal view of the Westlock greenhouse
 - 41 View of the gutter, the galvanised steel is showing serious signs of metal erosion primarily caused by water sitting in the gutter over many years

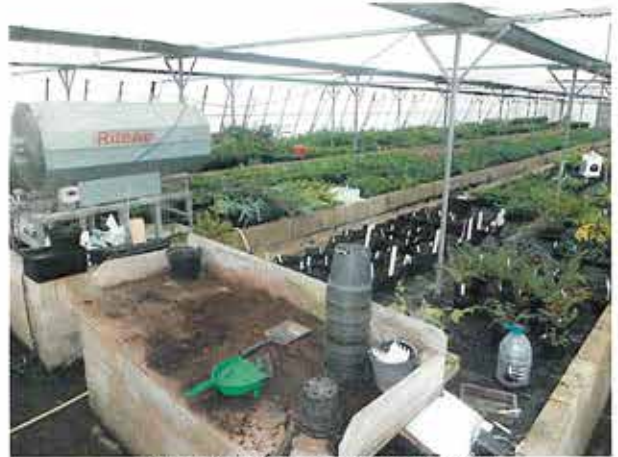
Fibrex Nurseries 04 12 18 (44)

- 44 View of the right air frost protecting heater
 - 45 View of the farm workshop building
 - 46 & 47 Internal views of the workshop building
 - 48 View of one of the three Duncan tucker propagating houses
